Taking the Fifth

By Mike Weinberg
Contributing Editor

The New Venture 4500 has become a familiar 5-speed transmission in heavy-duty pickups and stripped chassis built by GM and Dodge. A cast-iron 5-speed with an aluminum shift cover, all speeds synchronized, this unit is torque rated at 450 lb.-ft.. Weighing in at a hefty 195 pounds, it can be used in vehicles up to a combined gross weight of 19,000 pounds. The NV 4500 is manufactured in 2- and 4-wheel-drive versions.

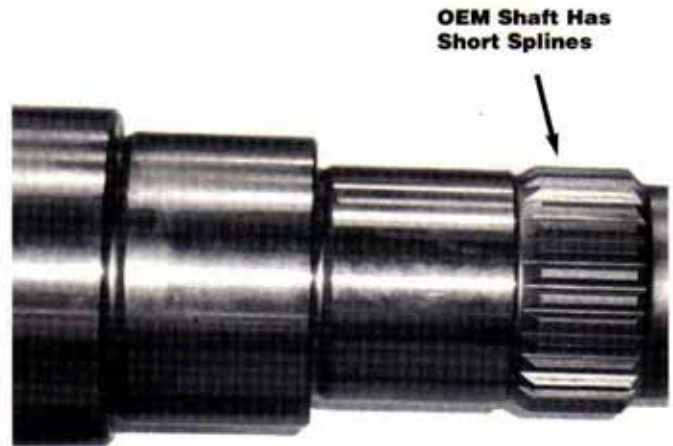
OEM shaft showing short spline length

While Chrysler worked to solve the problem, the gearheads in the aftermarket found the problem and created a lasting solution. Anyone who has worked on one of these units knows that the splines on the mainshaft 5th gear run the length of the bore but the splines on the mainshaft are about half the length of the gear. It seemed that increasing the mainshaft splined length would solve the problem, but that did not explain why the nut backed off.

Studying the splines showed that the angles of the two mating splines were such that under heavy torque loads, the mainshaft gear actually could turn slightly on the shaft. This continual movement, though very slight, was enough to

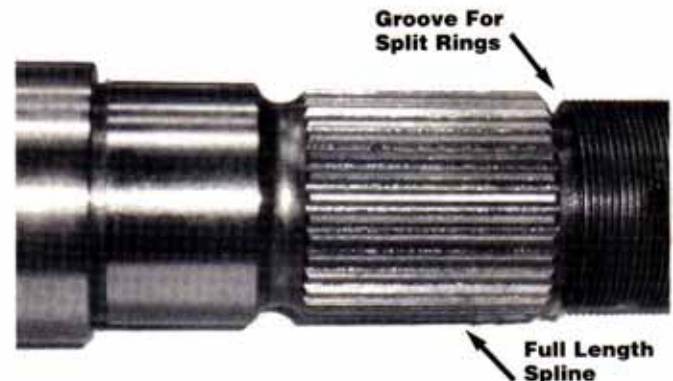
**Aftermarket shaft with full length spline
Groove for split rings**

back off the nut over time. The aftermarket-design output shaft has full-length splines of the proper angle. A groove is machined on the shaft behind the gear, and a set of split rings is placed behind the gear with a circular retainer, which keeps the rings in place. A new mainshaft locknut now tightens the split rings to the mainshaft 5th gear, and the fix is complete. The gear no longer can turn on the shaft, and the thrust load is absorbed

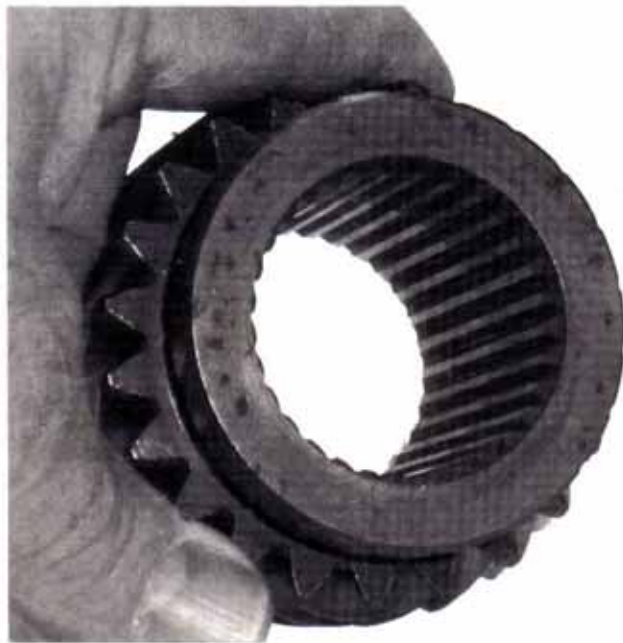
The splines on the mainshaft 5th gear are full length. The shiny area on the spline shows where it rides halfway on the OEM shaft

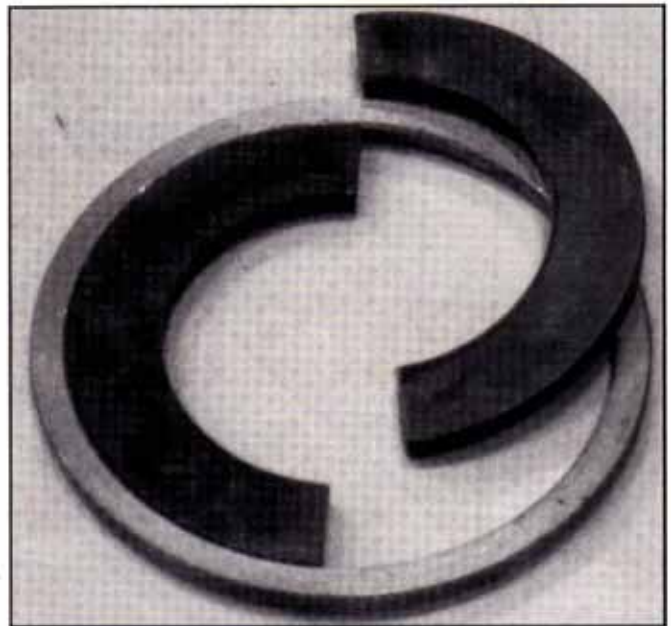
Split rings and retainer positively hold the gear in place and prevent any movement of the lock nut.

by the split rings without contacting the locknut. The shaft replacement kit now is available and is reasonably priced.
