Up To Standards

Mitsubishi Magic

The Final Chapter On The Mysteries Of The KM 160-180 Series Transaxles

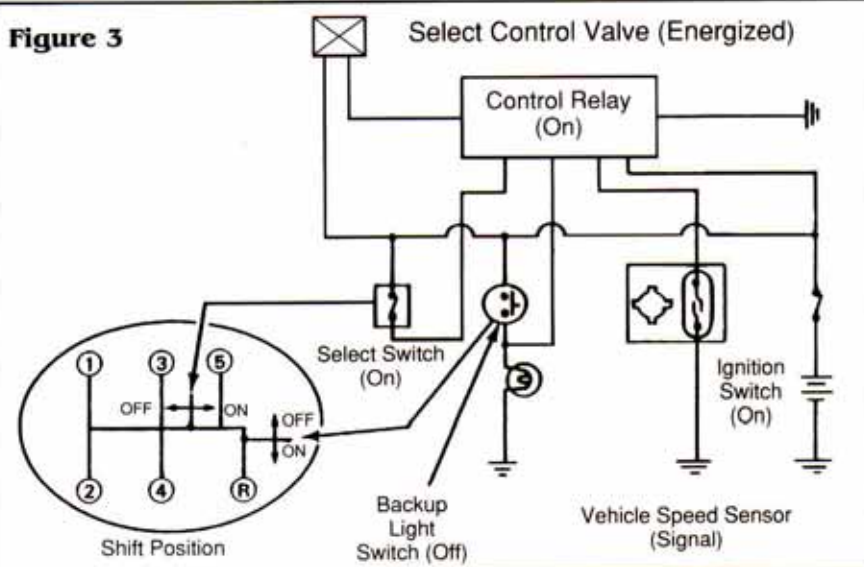
Figure 3

The next steps are quick electrical checks to locate the cause of complaints of no shift to 5th (See Figure 3). Verify that the backup lights are working correctly when the unit is shifted into reverse. The reverse-light switch and its wiring may be at fault, or the checkball under the reverse-light switch may have been lost on a previous repair.

Next we move to the Select switch that is mounted on the transaxle case or on the shift linkage, depending on which model you are working on. Disconnect the switch at the harness and connect an ohmmeter to the two wires. Have someone sit in the car and hold the shift lever halfway between 4th and 5th gears on the neutral bar. The switch should close and provide continuity. If there is no continuity, loosen the

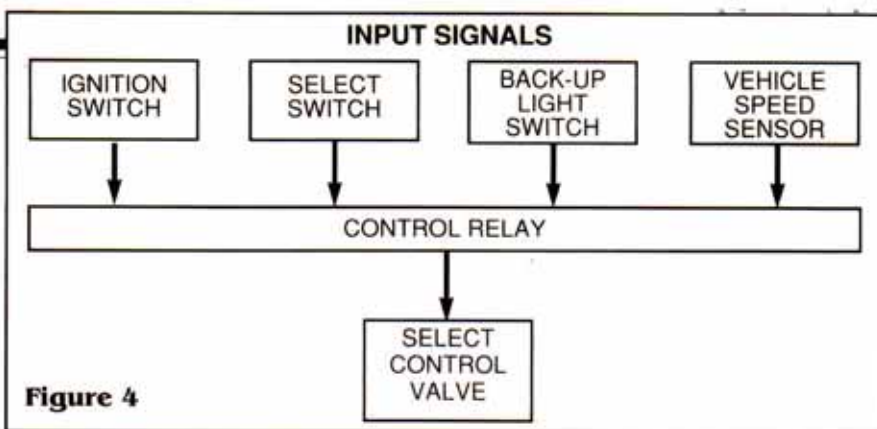
Figure 4

ful, the reverse-light switch interrupts the circuit and prevents the input shift rail from moving. This is why it is critical that the backup lights be functioning correctly. Be sure to reconnect the select switch after adjustments have been made (See Figure 4).

If continuity cannot be achieved, the switch is no good and should be replaced. When the driver moves the stick across the neutral gate to shift to 5th, it is the closing of the select switch that powers the Select Control Valve to port vacuum to move the input shift rail to the overdrive side. A misadjusted switch will cause a no-5th condition, a grinding shift to 5th or 5th-gear jump-out.

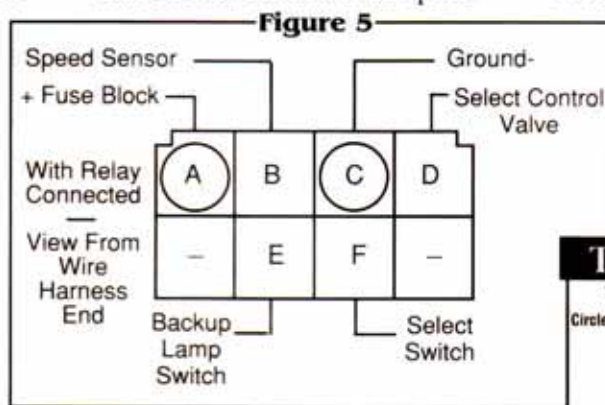
Figure 5

We now have eliminated the select switch and the reverse lights as possible causes of no 5th gear. The next items to check are the vehicle's speed sensor, which is in the speedometer head in the dash; the Select Control valve solenoid, and the 5th-speed control relay (See Figure 5). Don't panic; these are all simple to test. Disconnect the wire connector at the 5th-speed select-control-valve solenoid. Hook up a voltmeter be-

tween the red wire on the control-relay side of the connector and battery ground. Turning on the ignition should give you battery voltage. If battery voltage is not present, check the fuse or repair the open in the red wire. Locate the 5th-speed control relay on the driver's-side kick panel under the dash. It has an 8-pin connector with two black slots and 6 wires. With the relay connected, back-probe pins A and C with the voltmeter. A is battery voltage from the fuse block, and C is the ground circuit. With the ignition on, battery voltage should show between A and C. If there is no voltage, there probably is an open in C and the ground circuit must be repaired. To test the speed sensor (which will permit a shift to 5th only at road speeds above 6 mph), back-probe control-relay terminals B(+) and C(-) with an analog voltmeter. With the ignition on, hold one wheel and rotate the other slowly by hand. The meter should sweep from 0 to 5 volts, indicating the speed sensor to be working properly. If the needle does not sweep, check for an open or replace the speed sensor. Back-probe terminals F(+) and C(-) with the voltmeter. With the ignition on and the shift lever in 5th gear, battery

Back-probe terminals E(+) and C(-) with the ignition on and the shift lever in reverse; we should see battery voltage. This ensures that the signal from the backup lights is reaching the control relay. To test the control relay, back-probe terminals A(+) and D(-) with the voltmeter. With the engine running and the transmission shifted into 5th at a road speed

above 6 mph, we should see battery voltage. If not, the control relay has seen better days and should be replaced. If the relay is functional but 5th cannot be achieved, there is an open between D(-) and the select control valve
