## Understanding the New Venture 249 Transfer Case

By Mike Weinberg Contributing Editor

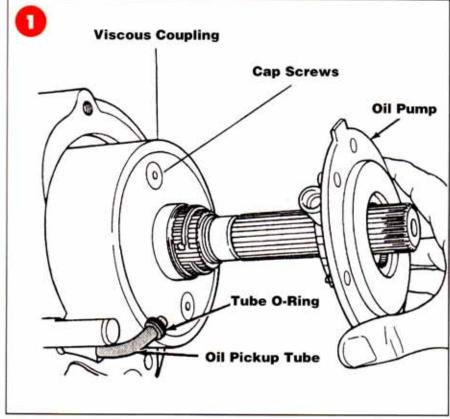
shifted or used a manual shift lever with simplified ranges. The NV 249 was designed as a manually shifted transfer case with a minimum of driver input. This unit has two operating ranges and a neutral position. For all normal driving the unit is left in the 4 HIGH range. For limited off-road use, a low-range position provides extra gear reduction through a planetary system. Low range should be used only for off-road travel and never

The NV 249 is a torque-ondemand unit that uses a viscous coupling to divide power between the rear and front axles. The viscous coupling is a sealed, non-

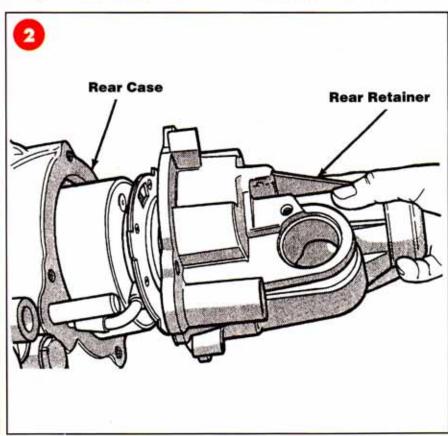
the unit. The common failure of the viscous coupling comes from continual overheating that damages coupling. Once the silicone fluid is contaminated with ATF, the party is over. This is why you open the

In the 249 transfer case the viscous coupling is on the transfer-case output shaft under the gerotor-type oil pump. Remove the transfer-case extension housing, the speedometer drive gear, the oil pump and the snap rings that retain the viscous coupling. Slide the viscous coupling off and place it on the bench with the two cap screws on the rear cover upright.

There is no way to test this coupling accurately, but there is a way to confirm that the coupling is bad. Making sure that the coupling is upright with the two cap screws facing the ceiling, open one of the cap screws. If the coupling is bad, a volcano-like stream of ugly brown, tar-like fluid will flow out of the screw hole. This is a sure indication of a coupling that has gone to the great scrap heap in the sky.
